The Use of Computed Tomography to Analyse Grinding Smudges and Subsurface Defects in Roller Bearing Rings

This article shows that changes occurring on the surface of roller bearings in the form of grinding smudges stem from the subsurface material defects of these elements. The authors discuss how the smudges are created and show the results of computed tomography tests conducted for roller bearing rings with the above-mentioned defects. The ring reconstruction images are presented, and the defects are located and described with the use of reverse engineering. The defects identified are presented in radiographs. The topography tests confirmed the existence of subsurface defects that emerge on the surface in the form of smudges, once the grinding of an element starts.

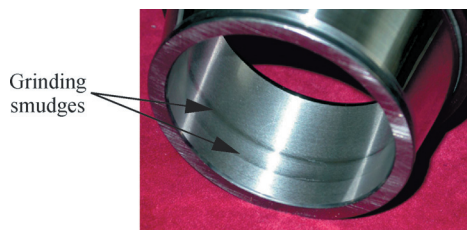
Visible symptoms of the existence of inner defects in the structure of the investigated material are surface smudges stemming from the grinding process (Fig. 1).

Fig. 1. Grinding smudges on the inner ring of the roller bearing

Such material defects resulting from the rolling, forging or casting processes are usually filled with impurities from metallurgical or forging processes. The grinding wheel opens up the material discontinuities, extracts the impurities, and smudges them over the ground surface, which creates smudges of different colours and lustre. The size of the smudge depends on the kind, shape, and location of the discontinuity. The greater the size of the discontinuity, the wider and clearer the smudge. Even when the opening in the discontinuity of the material is small, the smudge can be visible to the naked eye, not to mention specialised optical inspection systems. A roller bearing ring with the detected defect in form of a grinding smudge should be excluded from any further manufacturing process.

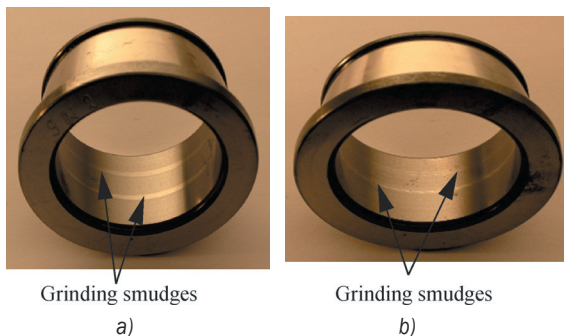
The A and B roller bearing rings with visible grinding smudges made of the 100Cr6 steel were tested (Fig. 2). The hardness of the surface after the heat treatment was 58 to 62 HRC.

Fig. 2. Test objects for rings: a) A and b) B

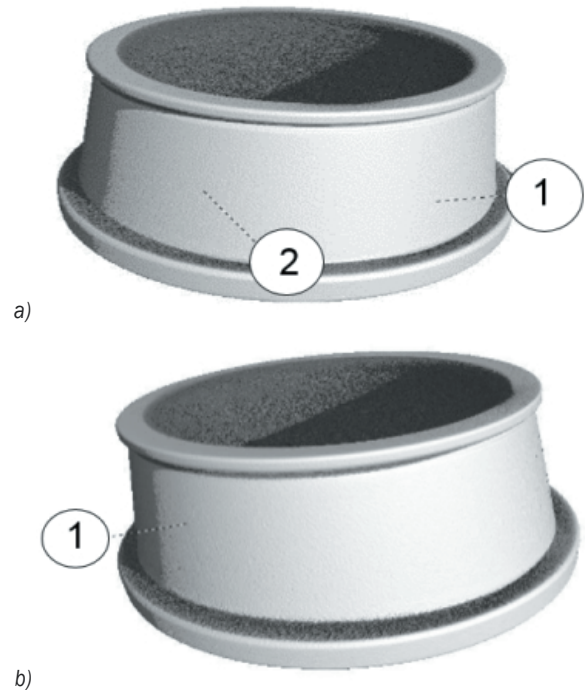
3D images were obtained for both A and B rings. A method of computed tomography was used (Fig. 4) to detect the location of the defect (marked with numbers 1 and 2).

Fig. 4. Tomography reconstruction image for rings
a) Ring A and b) Ring B

In the case of Ring A, two discontinuities were detected; whereas only one defect was detected in the case of the other ring. In order to enable a more detailed description of the defects, three perpendicular sections of the reconstructed objects were created. They allowed the determination of the character, orientation and the topography of the discontinuity. The examples of the images of Defect 1 in Ring A in the defined axes are depicted in Fig. 5.

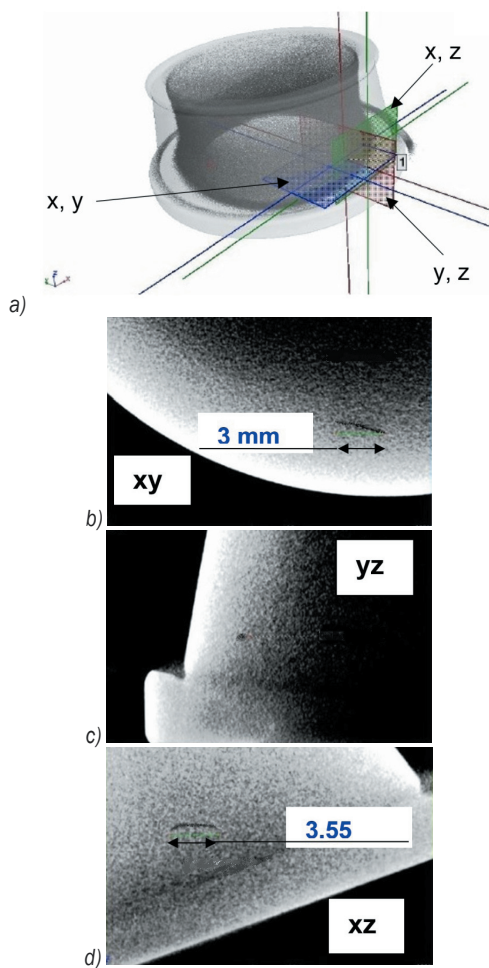
Fig. 5. Selected images of sections in xyz axes of Defect 1 in the reconstruction of a) ring A, b) xy intersection, c) yz intersection, d) xz intersection

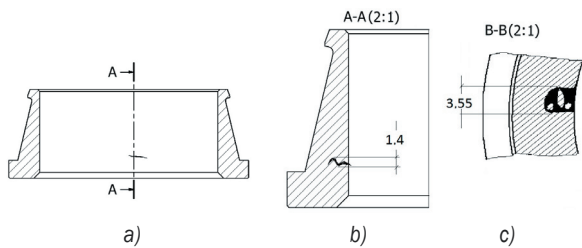
Discontinuity 1 in Ring A is similar to the crack or the flattened cavity with extended topography in the direction perpendicular to the inner surface of the ring (Fig. 6).

Fig. 6. Cross-sections and a draft of the defect propagation - Defect 1, Ring A - dimensions in mm: a) intersection, b) part section A c) part section B

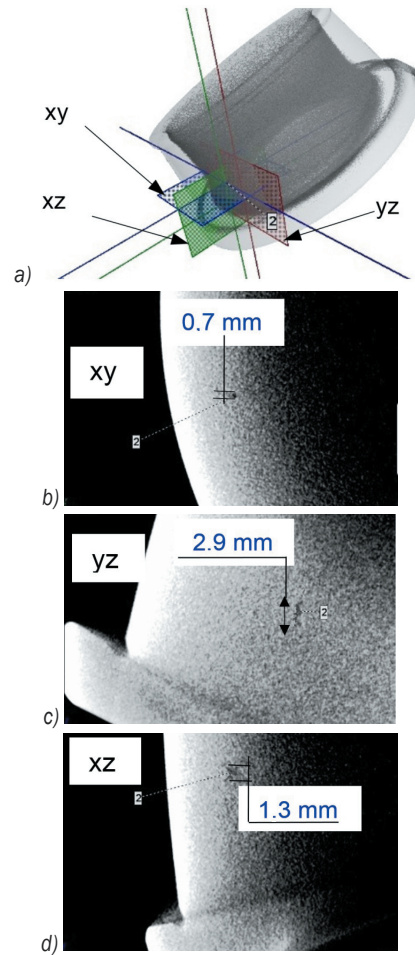
The examples of the images of the area in which Defect 2 was observed for Ring A are shown in Fig. 7.

Fig. 7. Selected images of Defect 2 cross-section in planes XY, YZ, XZ in reconstruction of Ring A: a) ring A, b) xy intersection, c) yz intersection, d) xz intersection

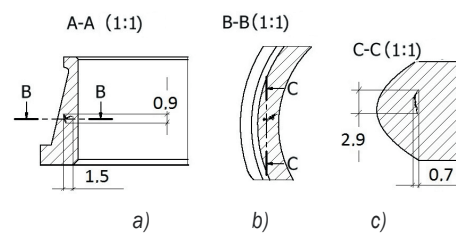
Defect 2, similar to Discontinuity 1, has the form of a crack or a flattened cavity. It is smaller than Defect 1, and its shape is more irregular (Fig. 8).

Fig. 8. Cross-sections and a draft of the defect propagation - Defect 2, Ring A - dimensions in mm: a) intersection, A b) part section B c) part section C

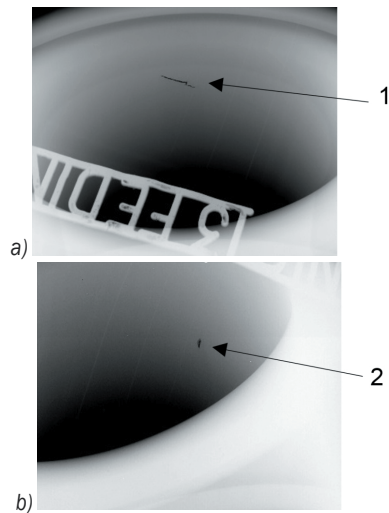
Fig. 9 depicts the radiographs for Ring A with a clearly visible Defect 1 and a tiny, even at greater magnification, Defect 2.

Fig. 9. Radiograph for Ring A: a) defect 1, b) defect 2

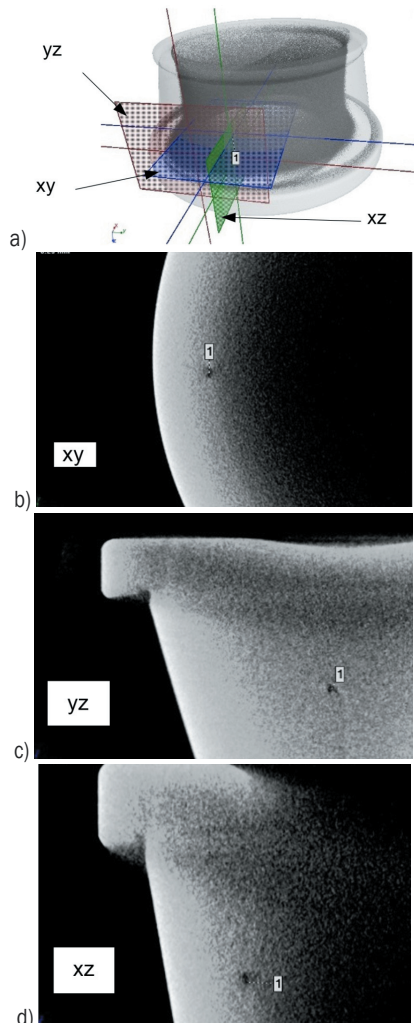
In the central part of Ring B, a discontinuity of extended structure was observed. The middle of the defect has the form of a cavity in which the propagating discontinuities (crack-like) are rooted (Fig. 10).

Fig. 10. Selected images of Defect 1 cross-section in planes XY, YZ, XZ in reconstruction of Ring B: a) ring B, b) xy intersection, c) yz intersection, d) xz intersection

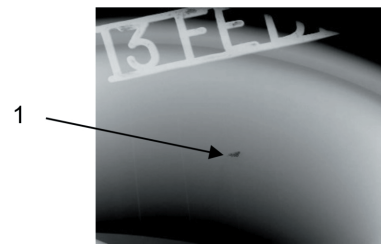
The defect is also visible in Fig. 11 presenting the radiograph of Ring B.

Fig. 11. Radiograph for Ring B
