# Analysis on Damage to Rolling Bearings at Small Turning Angles

Ivan Okorn\* – Marko Nagode – Jernej Klemenc

University of Ljubljana, Faculty of Mechanical Engineering, Slovenia

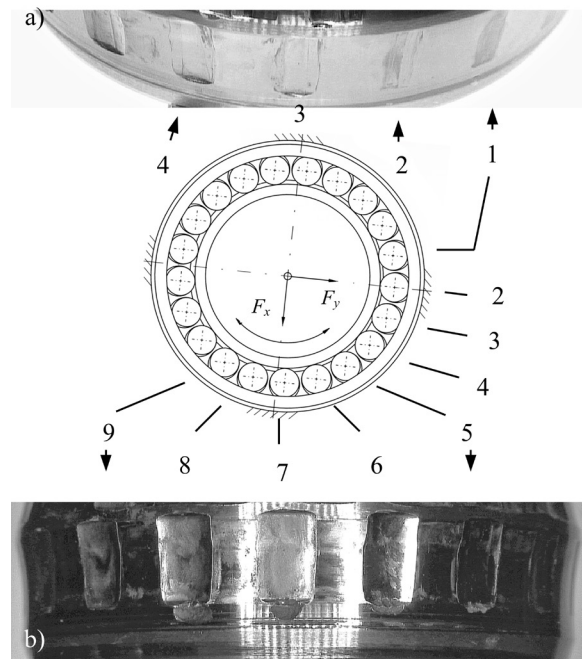
The damage that occurred after three months of the test rig operation at the testing frequency of 3.3 Hz was analysed. Damage occurred under thirteen rolling elements, both on the outer and inner bearing rings. Depressions are deeper on the internal ring. The change of the diameter of the rolling elements is negligible. Only a trace of a contact with a rolling element can be seen under the first and last rolling element, without a significant material removal. Depressions of various depths can be seen under all other rolling elements.

Depression depth increases from the second to seventh rolling element and then decreases. Depressions on the internal ring are shown in Fig. 8. Fig. 8a shows how damage depth increases under individual rolling elements. The location and extent of the damage is consistent with the distribution of load on the individual rolling elements. Deeper depressions formed under the elements that are loaded continuously.

**Fig. 8.** Defect at the surface of the raceway;  
a) damage depth under individual rolling elements 1 to 4,  
b) damage depth under rolling elements 5 to 9

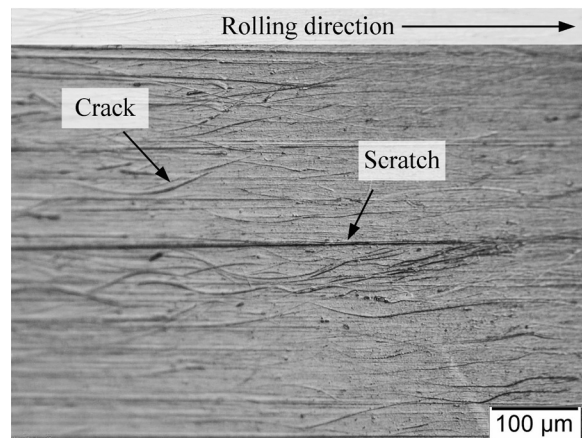
Only a trace of the rolling element can be seen on the internal raceway at the first rolling element, while the first traces of material removal can be seen at the third one. The damage at elements 3 to 7 is similar, with the extent of damage becoming larger. Damage 1 is shown in Fig. 9. When the surface was examined with an optical microscope, cracks were detected in the direction of the roll. Electron microscopy confirmed the fatigue cracks.

**Fig. 9.** Damage 1; cracks on the surface

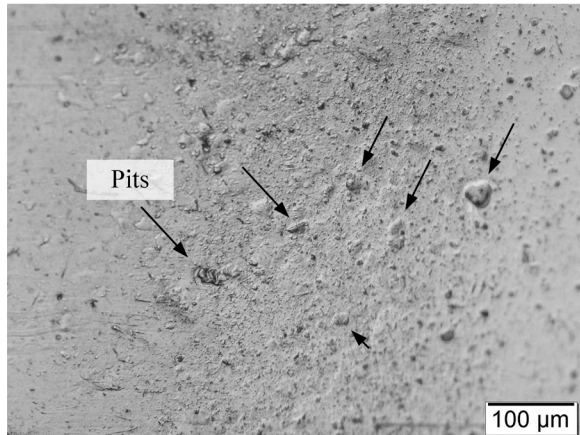
In the case of damage 3, the progression of the surface fatigue is visible, with a typical surface full of small pits (Fig. 10). Progression of cracks can be seen in some parts of damage 3 (Fig. 11). There are no oxidation products that would indicate fretting.

**Fig. 10.** Damage 3; pitting of the surface

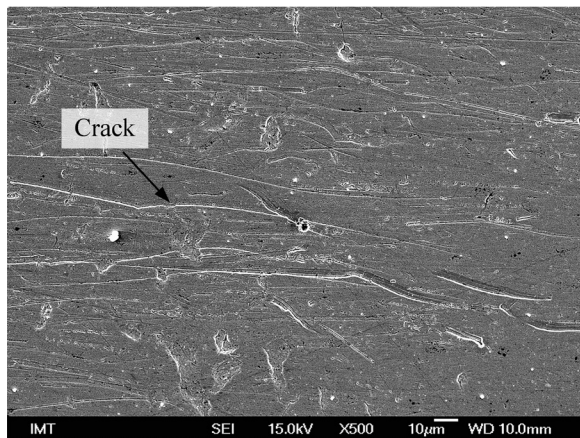
**Fig. 11.** Damage 3; progression of cracks

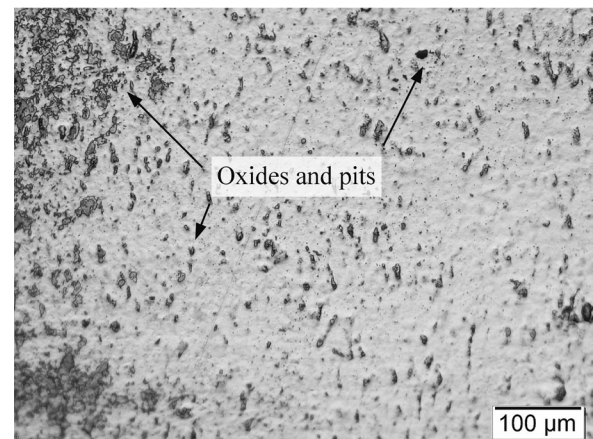
Damage 5 is deeper and wider than damage 3. The surface of the damage is shown in Fig. 8b. Pronounced removal of material with pitting can be seen in Fig. 12. Tribocorrosion and fretting wear occur on locations of pitting due to the uncovering of the metal surface. The wear mechanism is similar in damage 7, with the extent of damage being larger. Tribocorrosion is confirmed by the presence of red-brown surface areas. The presence of oxides was confirmed by electronic microscopy (Fig. 13). Oxides are harder than the surface material, so they act as abrasive particles between the roller and the raceway. The intensity of wear, therefore, increases further.

**Fig. 12.** Surface of damage 5

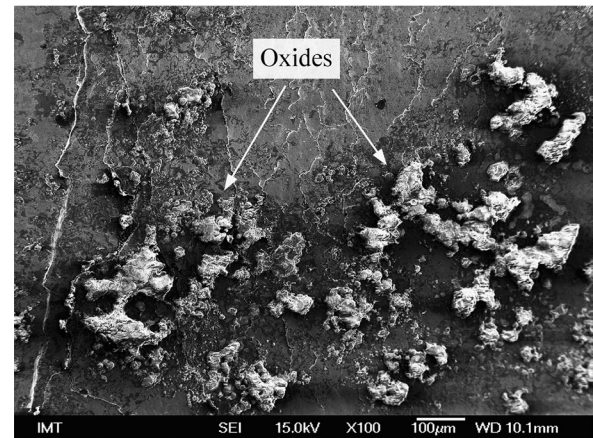
**Fig. 13.** Oxides on the surface of the damage

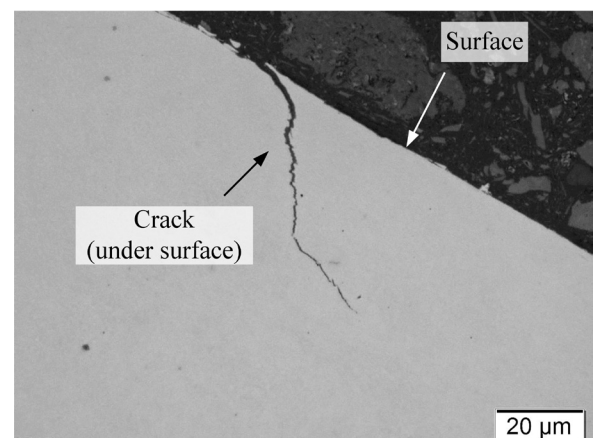
Each of the treated damaged samples was cut transversely. Figures showing the crack propagation

under the surface confirm the mechanism of fatigue. Widening of one of the cracks can be seen in Fig. 14.

**Fig. 14.** Propagation of cracks under the surface

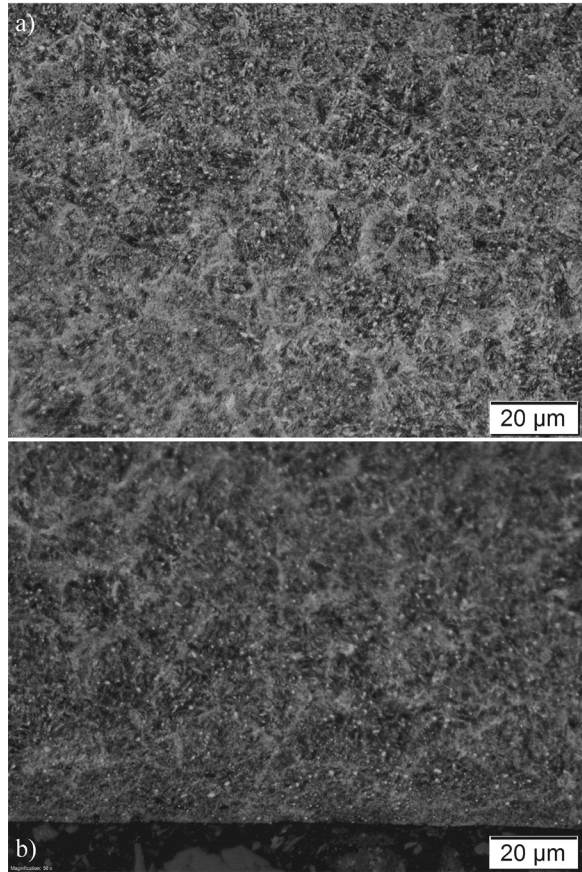
Microstructures in the core and under the damaged area in the cross section of metallographically prepared samples were compared. It can be seen from Fig. 15

that the microstructure is the same. This proves that the load of the contact area did not exceed the yield point, and there was no macro plastic deformation of the material.

**Fig. 15.** a) Core microstructure,  
b) microstructure under the surface of the damage

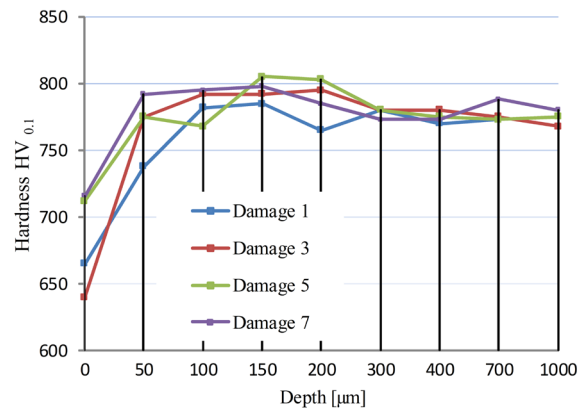
Distribution of microhardness of the material under the damage is shown in Fig. 16 for all four instances of damage that are the subject of this discussion. It can be seen from the profile that the surface does not become harder, which would be typical for the overload and macro plastic deformation of the surface of the bearing steel. A drop of hardness in the surface layer (50 µm micrometers to 100 µm thick) can be seen in all four instances of damage. A larger drop of hardness and the thickness of the layer with the reduced hardness are present at the early instances of damage (1 and 3). This indicates that a contact temperature increased ( $> 200\text{ }^{\circ}\text{C}$ ), which could lead to tempering of the material surface. The higher surface hardness at instances of damage 5 and 7 may be caused by the secondary hardening of the surface after the peeling.

**Fig. 16.** Microhardness under instances of damage
