Detecting Groan Sources in Drum Brakes of Commercial Vehicles by TVA-FMEA: A Case Study

Original Scientific Paper

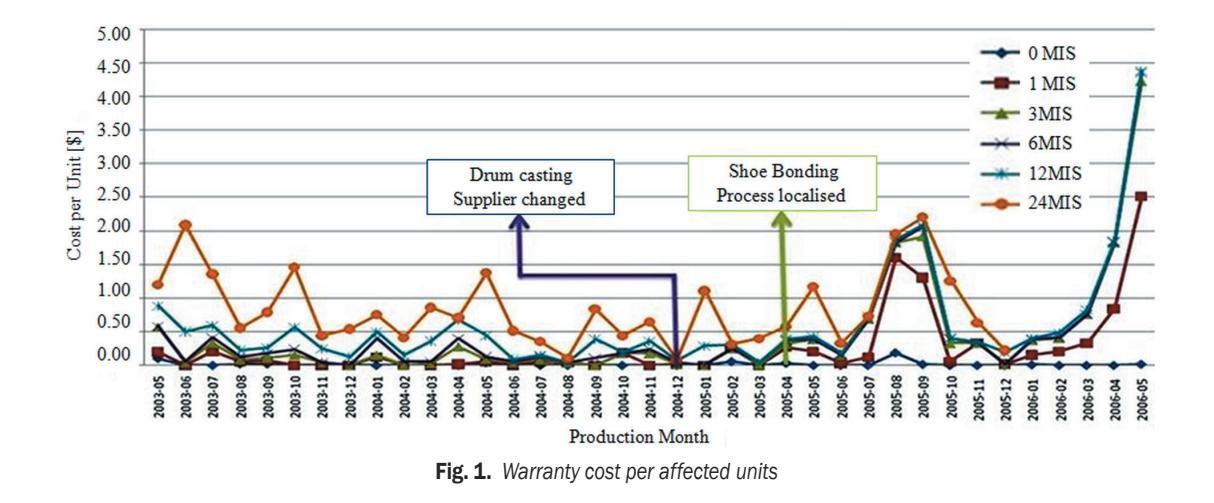
During analysis via the global warranty tracking database, it became clear that something had gone wrong in August 2005 as indicated in Fig. 1. According to the records, the drum casting supplier was changed in December 2004 and then the brake shoe lining process was given to a company working in the home market in Turkey in February 2005. The vehicles built after implementation of these changes had a lot of complaints related to NVH (noise, vibration, harshness) occurring during braking. The only repair method to deal with these complaints was to replace the affected parts under warranty, however this resulted in a considerable increase in warranty cost per month for the company. The collected complaints showed that the problematic unit of the light truck vehicle was the "drum brake system". Therefore, the company organized a team to investigate the root cause of the drum brake low frequency NVH problem. In the literature, brake noises were classified according to frequency ranges [1]. Groan is the low frequency noise 100 to 500 Hz. Thus, for a better understanding of the problem, various NVH departments of the company

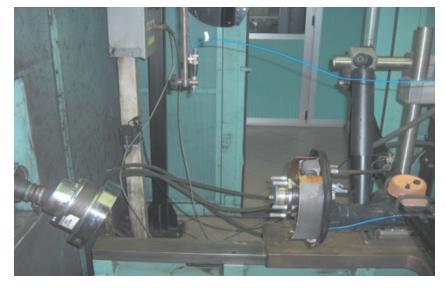
Fig. 5. Drum brake test rig constructed to study the groan problem

Several test trials were performed. However, the vehicle mass moment of inertia cannot be created dynamically and therefore the brake groan, which is defined by customers subjectively for the activated brake, cannot be generated under laboratory

conditions. Therefore test rig studies were stopped and it was decided that all NVH measurements should be performed under real working conditions using the affected vehicles while driving on the road. The test rig constructed in the laboratory to measure drumbrake groan for commercial vehicles is shown in Fig. 5.

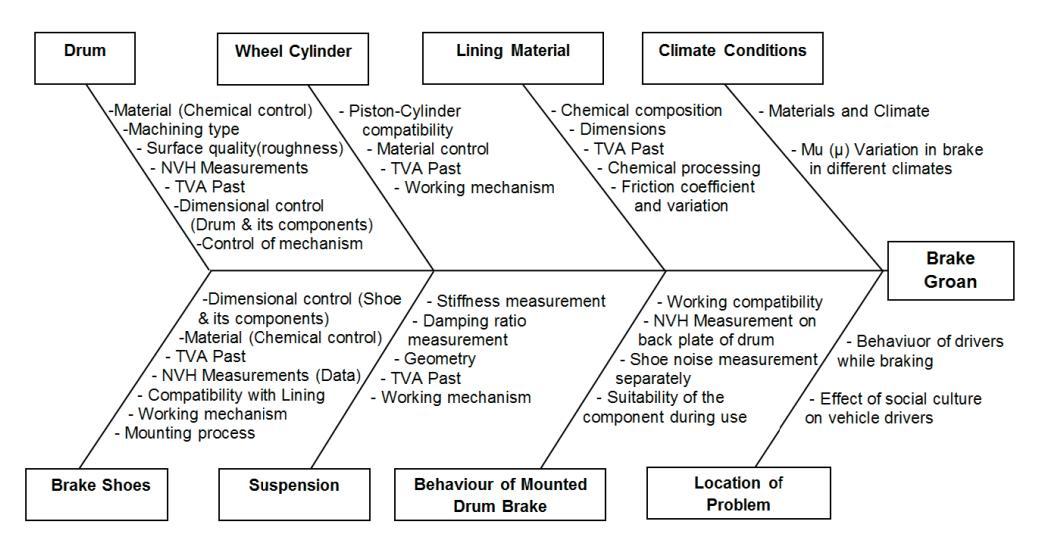
Fig. 4. Fishbone diagram to detect the reason for drum brake groan

All systems and components, as well as the quality of design and production processes, are reviewed within the fish bone diagram given in Fig. 4. The details of the tests performed on the systems and components are summarized below. In the fishbone diagram the most important item is the drum component of the rear brake system. Therefore, the drum was thoroughly investigated.

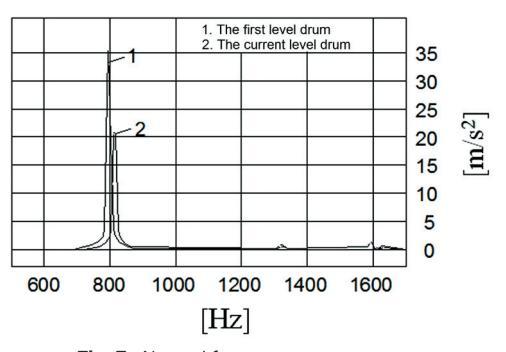
Fig. 7. Natural frequency measurement

The natural frequencies of the former and new castmanufactured drums were measured to see whether there were any changes in their frequency levels. The measured data are shown in Fig. 7. According to the specifications, the acceptable range of frequency characteristic function (FCF) for the drum is between 760 to 815 Hz. The new drum's natural frequency level was 814 Hz. The natural frequency of the etalon sample is 791 Hz.

Thus, the measured values of the former and new drums are within the specified range, which means that chemical composition and natural frequency parameters can be eliminated as a potential source of the groan.

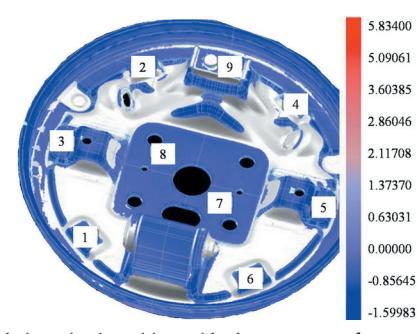
Fig. 8. A drum brake table and its important surfaces coded with numbers for use in other component montages

The main constructive parts of the rear drum brake are illustrated in Fig. 6. Here the second part of the left side is a wheel short shaft. The rear drum brake was studied in depth and some damaged surfaces on the brake table due to sharpness of corners of wheel short shaft were detected. A new technical drawing of the wheel short shaft was drafted providing a longer radius in order to decrease the sharpness of the corners. Machining of the new parts proceeded according to the modified drawing in order to eliminate contact scratches on the brake table. The more complex part in the drum brake mechanism is the brake table, which is shown in Fig. 8. 3D surface scanners were used in quality control for the machining of this part. Additionally an etalon was used for quality control of the mounting surfaces of the basic components.

Data collected for the numbered surfaces from 1 to 9 are summarized in Table 2. Here the most important machined surfaces are the surfaces coded as 7 and 8, which belong to the shoes and the wheel short-shaft. First, changes in the z axis were determined to be within acceptable limits after measuring the surfaces as indicated in Table 2. Then controlling of the other items was started.

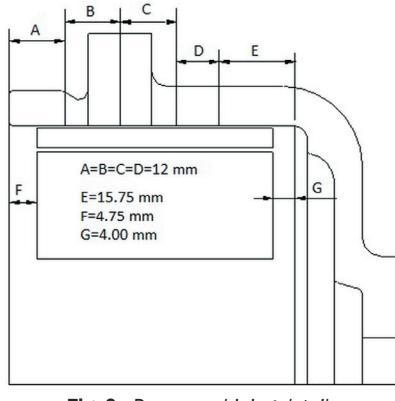
Fig. 9. Drum machining details

Machining of the drum was performed according to the specifications shown in Fig. 9 up to the start of the research program on the brake groan problem. Fig. 9 shows that machining of surfaces A, C and E was being performed at high feed rates, while surfaces coded as B and D were machined at low feed rates. The rule defined in Fig. 9 was to eliminate axial movement of the brake shoes and its lining material from the surface of the drum when the brake was being activated. During the research program aimed at identifying the root cause of brake groan, a small change was made related to the machining procedure for the drum.

The surfaces of drum B and D were machined at high feed rates and A, C and E were machined at low feed rates as indicated in Table 3. Observations and measurements were made to determine whether there was any decrease in the number of troubled vehicles manufactured from the lines. It became obvious that the high feed rate contributes to high surface roughness.

A rough surface accommodates the lining material of the brake shoe to the drum very quickly. It also avoids axial displacements of the lining material with the brake shoes when the system is activated. Thus, it was understood from the same measurements that if high feeding rates are used in the machining of the middle regions, which are the contact surfaces of the lining material, then the brake groan problem decreases as shown in Table 3. However, the results did not satisfy the project team as they did not show complete elimination of the rear drum brake groan problem. The statistical measurements did not show strong correlation between drum machining and brake groan. Therefore, the drum machining method is a reason but not the basic root cause of the groan of the

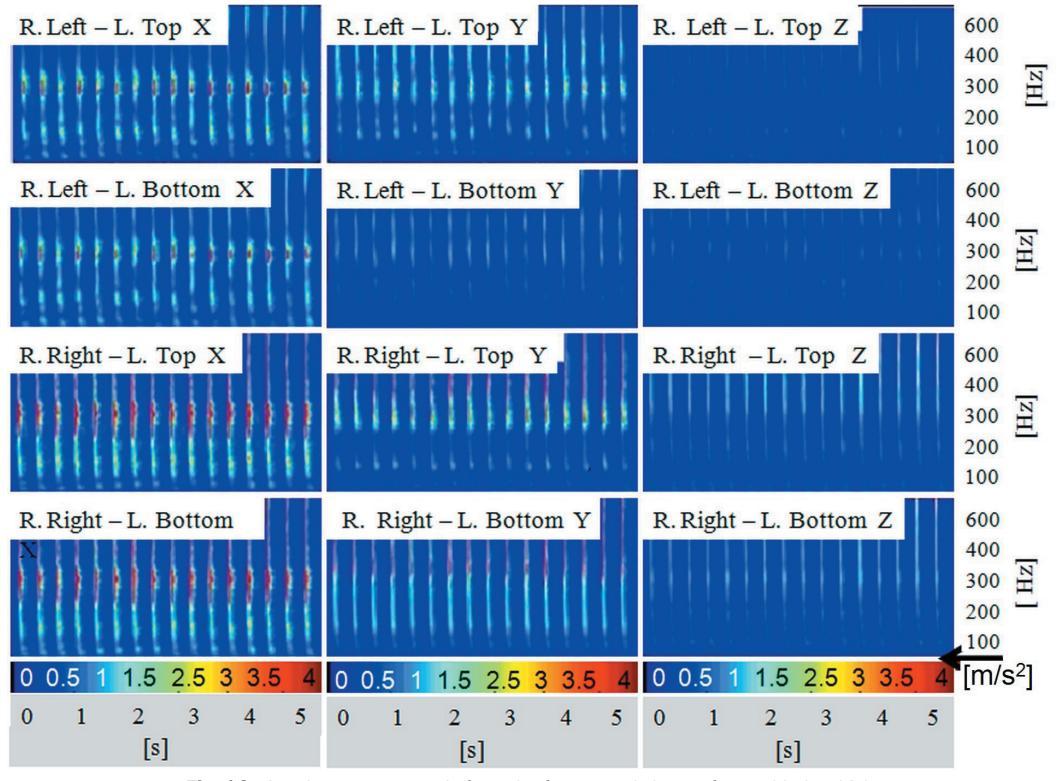
Fig. 14. Accelerometer records from the front metal shoes of a troubled vehicle

Analysis of the data coming from the first and second measurements did not yield any clear conclusions. However, the third measurement study did help to explain the collected data very clearly and pointed the way to identifying root cause of the problem. In the third trial, brake groan was found to be due to an activated faulty brake, which is triggered by the front metal shoe (leading) on the both sides of the drum brake of the vehicle as shown in Fig. 13. This is why this experiment was performed with the help of two accelerometers mounted in front metal shoe (the shoe in driving direction) of the drum-brake vehicle. The recordings are presented in Fig. 14. In Fig. 14, the first row indicates the measurements of the accelerometers located in the rear drum brake shoes that are, RL-LT (rear left-leading top) measures groan noise frequencies in x, y, z directions and similarly RL-LB (rear left- leading bottom) in x, y, z directions. For the right tyre, the accelerometer measured frequencies at RR-LT in the x, y, z directions and RR-LB in the x, y and z directions. After having completed an analysis of the graphics, it can be seen that the left side of the vehicle does not have any serious problems. But on the right side, variability in the acceleration of vibration can be clearly observed between 200 to 300 Hz. When we look at the charts for the right wheel of the vehicle, the x-axis of both top and bottom points shows the same variability. Moreover, on the y axis, the top portion includes more interaction, which hints that the source of the excessive vibration is near the brake lining. Finally all measurements performed in the tests point to something being wrong with the brake lining. In contrast to the other axes, records taken from the z axis show no big change. In the third test, the vehicle brake groan disappears spontaneously after applying the brake for a certain period of time (groan noise is completely eliminated after driving 5 km in traffic).

During the third trial, the frequency of the knocking groan noise occurrence at the drum brake was also measured and a continuous error mode has been detected. Although vehicle speeds and brake forces differ from each other, records show that the braking groan noise, which is heard as "knock" at each rotation of the wheel, repeats itself regularly. The knock occurs when the wheel speed was calculated to be 2.7 cycles per second, more specifically the knocking occurrence frequency is ~2.75 rotation per second. Thus, measurements show knocking at each rotation in the braking system as shown in Fig. 15. The groan noise recorded in the cabin is shown in Fig. 16. In Fig. 16, the blue line (R. Right - L. Bottom X) indicates groan noise magnitude collected from the lower portion of the brake metal shoe and the red line"(R. Right - L. Top X) shows the data from the top portion of the same metal shoe. The green line (R. Right - Microphone) seen in Fig. 16 indicates the levels of braking groan noise measured in the cabin. Although the groan created during braking is actually very high pitched, we hear only a small portion of it due to the quite effective insulation applied to the cabin. A third trial, in addition to the studies described

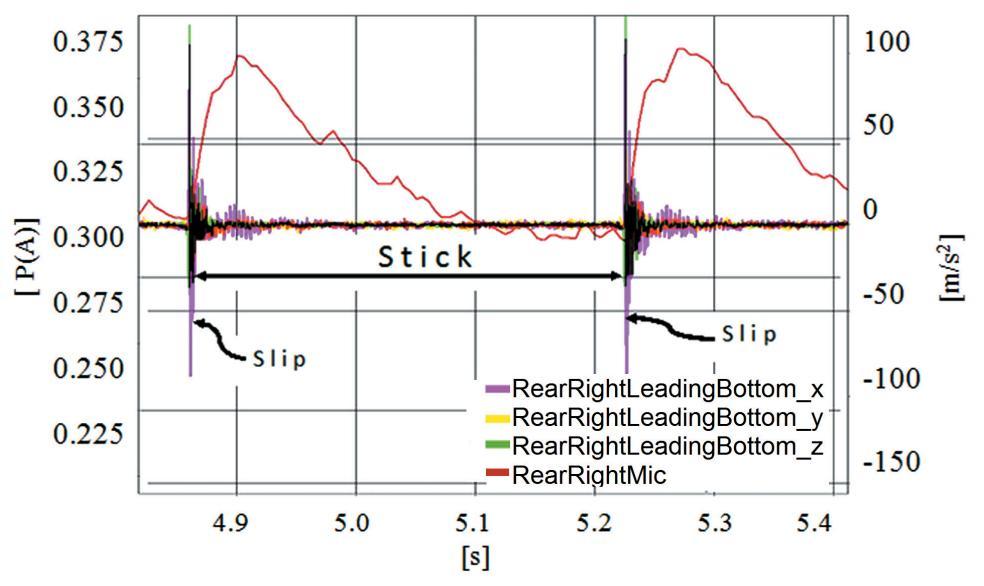
Fig. 17. Vibration and groan noise records of the shoe pad contact on the drum during activation

According to the file describing this movement, when braking is triggered, the brake lining is trying to hold onto the drum surface due to the force applied by brake but gripping of the shoe lining to the drum surface is not occuring. The shoe lining tends to cause displacement of the pinned shoe surface. This can be described as a dynamically forced motion. Thus, after the braking force stops, the restoring forces on the

braking shoe should displace the lining to its initial position. When this movement occurs, the friction coefficient between the drum metal and lining material decreases significantly and braking is performed only by pushing two different materials towards each other.

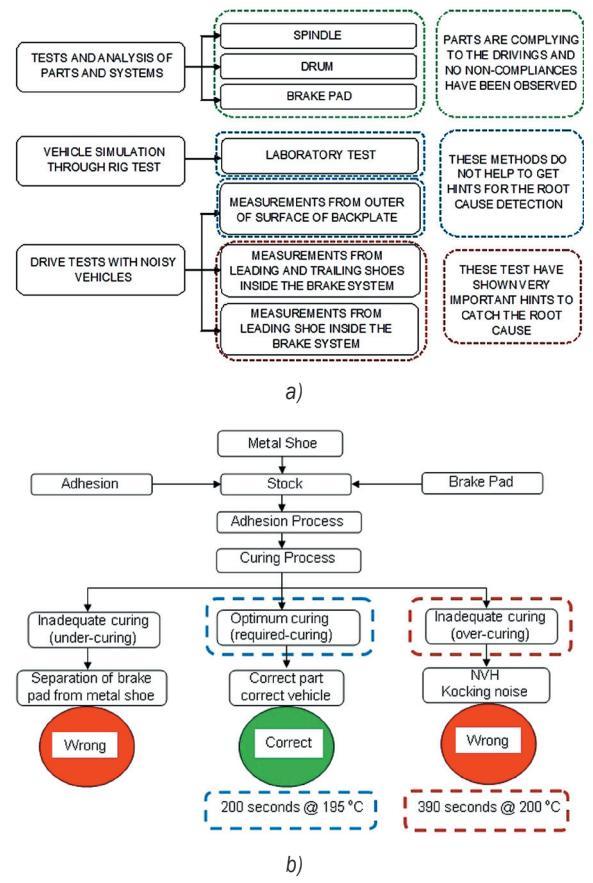
Fig. 18. a) Schematic view of the planned tests and b) bonding process of lining material

The items presented in the red dotted line are important indicators in determining the root cause. Fig. 18b shows the shoe bonding process and the negative effects of process variability. The effect of the curing process timing was analysed under laboratory conditions by the brake lining supplier and confirmed that the variability in the curing timing has an important effect on groan noise generation. The friction coefficient (μ) of the brake lining has been indicated as $\mu = 2.0$ to 2.5 in the supplier specifications. In order to understand how the friction coefficient varies between "groan noise" and "groan noise-free" brake linings, 3 sets from both vehicles were disassembled from the vehicles and shipped to the supplier for analysis. Measurements related to the friction coefficient are summarized in Figs. 19a and b for groan noise free and groan noise respectively.

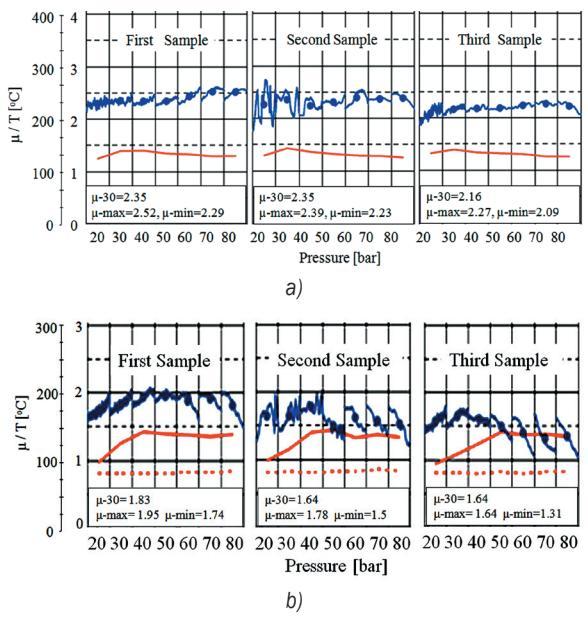
Fig. 19. Measurements (friction coefficient, temperature and brake pressure) on a) groan noise-free and b) groan noise brake lining materials

According to test results, the friction coefficient μ of groan noise free brakes ranges between 2.09 and 2.52. On the other hand, the coefficient μ of the groan noise brakes shows fluctuations between 1.31 and 1.95. Because of the overcuring of the composite

material under heat, the surface of the lining material becomes excessively crystallized, which decreases braking efficiency. Due to a loss of braking effects upon contact with the drum's internal surface, the lining works as a pressure applicator on the drum only and this results in vibration under dry friction. After having determined the root cause of the problem, the drum brakes of all vehicles in the production lines are manufactured using correctly cured lining materials.
