Experimental and Numerical Studies of Jaw Crusher Supporting Structure Fatigue Failure

Eugeniusz Rusiński – Przemysław Moczko* – Damian Pietrusiak – Grzegorz Przybyłek
Wroclaw University of Technology, Poland

In this paper, studies into the causes of fatigue cracks of a jaw crusher supporting structure are presented. The problems appeared after short time of operation at a new crushing facility. A large number of fatigue cracks with a high growth rate and bolt failures were observed in the crusher supporting structure. Considering the high dynamic forces that occur during the operation of such equipment, an investigation into the problem was undertaken in order to prevent catastrophic failure of the crushing station. A specially developed, combined numerical and experimental method was used to determine the reasons for the problems and to solve them.

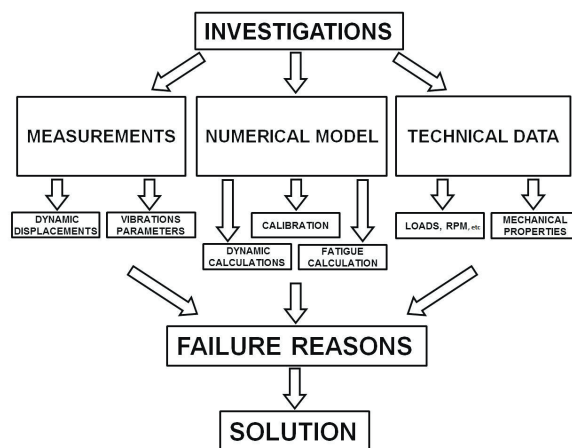
Fig. 1. Investigation procedure for determining the reasons for failure

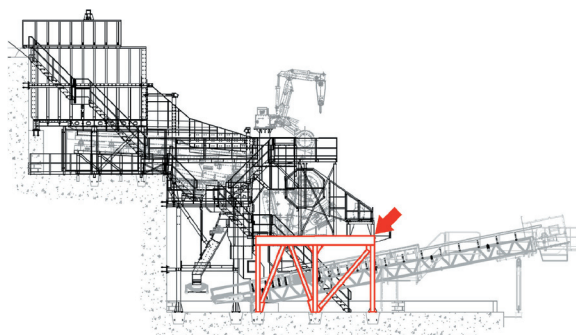
Application to a real structure failure was carried out at one of the Polish mines. The crushing station consists of typical equipment such as a chute, conveyor system, hammer and jaw crusher, which is supported by a steel frame anchored to the concrete foundations. A view of the crushing station is shown in Fig. 2.

Fig. 2. Jaw crusher layout (supporting structure highlighted in red, marked with arrow)

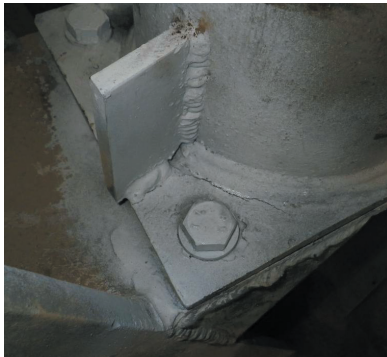
structure were observed. A view of the cracks in the side vertical bracing is shown as an example in Fig. 3.

The growth rate of fatigue cracks was high. The maximum length of cracks was found to be 160 mm. The significant level of damage meant that immediate action would have to be taken in order to prevent

Fig. 3. Fatigue crack in the side bracing

According to the FEM calculations on the existing structure, the fatigue resistance of critical joints (see Fig. 11) does not fulfil ISO-5049 standards [8]. This was confirmed by the presence of the many cracks observed in these areas (an example of such cracking is shown in Fig. 3).

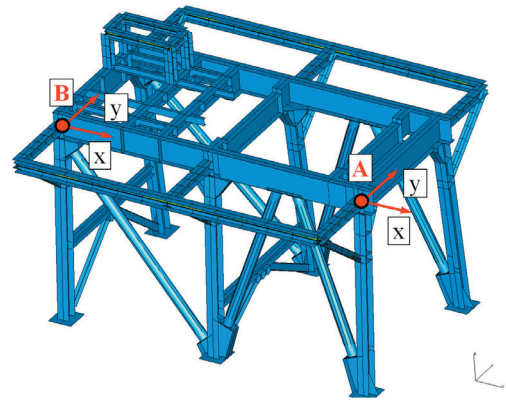
Tests were performed at two points (A, B, Fig. 4), where displacements of the structure were measured in two horizontal directions, x longitudinal and y transverse.

Fig. 4. Locations and directions of the measuring points

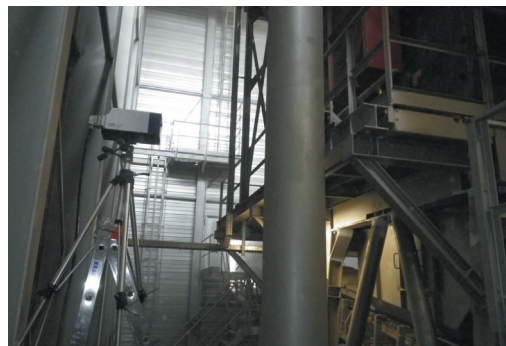
Fig. 5. Scanning head of the POLYTEC PSV-400 vibrometer

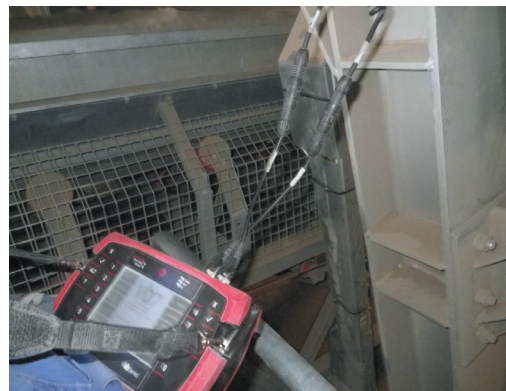
Fig. 6. COMMTEST vb7 vibrometer

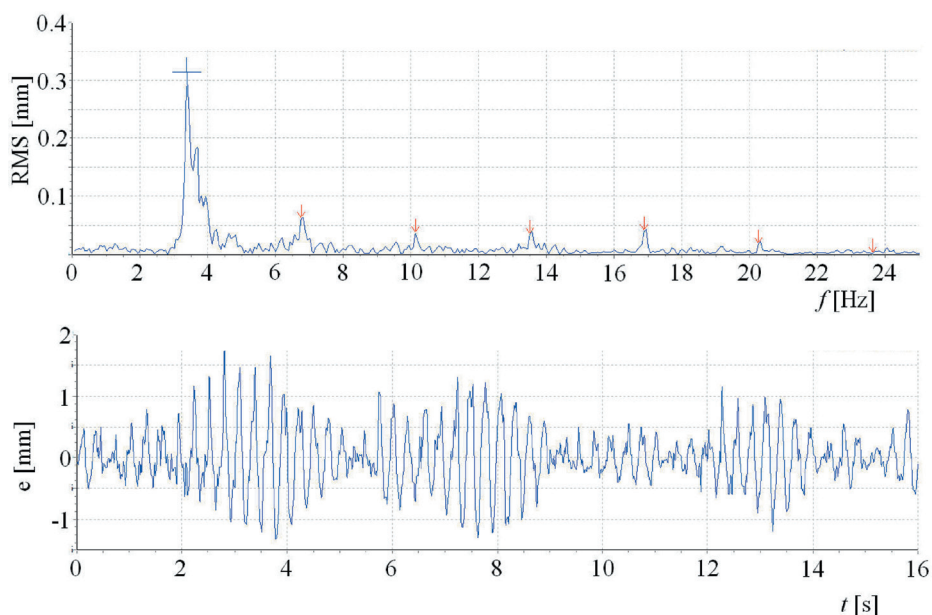
As a result of the measurements, a vibration spectrum and time traces were obtained. An example of a graph of the measurements results is shown in Fig. 7. The transverse vibrations of the structure are caused by resonance effects, which can be seen in the time traces of the vibrations where a characteristic beat effect is present.

Analysis of the measurement results led to the conclusion that the structure operates at a resonance condition close to the excitation frequency $f_{ex} = 3.33$ Hz.

Fig. 7. Time and spectrum trace with a visible resonance effect - transverse displacement

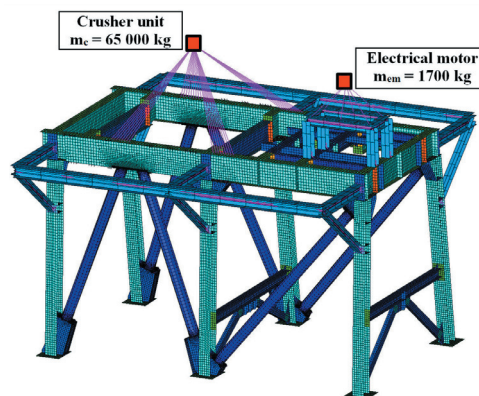
As a first step, a numerical model of the crusher's supporting structure was created. Shell modelling was used to evaluate the exact stress effort and deformation of the structure. Such an approach enables the calculation of stress level in the notches, which is impossible with the use of beam modelling. Fig. 8 presents a model of the supporting structure with the shell elements generated. The model consists

of a linear shell, beam, as well as rigid and spring elements. Mass elements (squares) simulate the self-weight of the equipment placed on the supporting structure, such as the crusher unit, electrical motor, etc. There are 58000 elements and a similar number of nodes generated in total in the model of the structure. The boundary conditions consist of restraints and loads. Supporting points of the entire structure were restrained to simulate the behaviour of the real structure. The loads applied in the simulations are based on the results of the measurements and are described in the section below.

Fig. 8. Numerical FEM model of the supporting structure

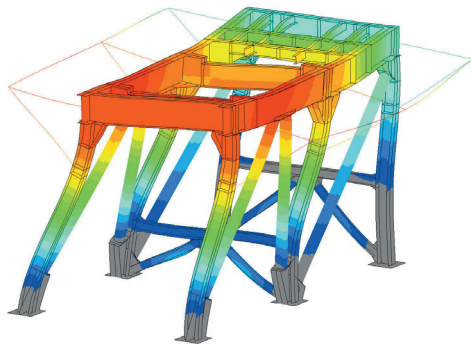
Numerical modal analysis of the model confirmed the presence of the resonance effect under operating conditions. Table 2 lists the frequencies of the first three modes. Fig. 9 presents the deformation plot of the first mode, which is responsible for the resonance vibrations. The direction of the vibrations is in line with those measured on site and the frequency is close to the excitation load (f_{ex}), which is $f_{ex} = 3.33$ Hz, $f_1 = 3.39$ Hz, $f_{ex} \sim f_1$.

Fig. 9. Natural frequency mode shape of the crusher's supporting structure - Mode 1

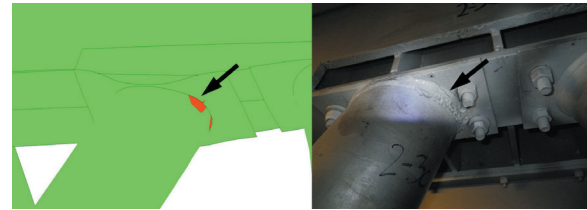
The results of fatigue calculations confirmed that the areas where cracks are present on the structure are overstressed and do not have proper fatigue resistance. There was 100% correlation between the cracks locations on the real structure and those in the numerical model (an example is shown in Fig. 10).

Areas, marked with arrows on the numerical model, indicate fatigue problems.

Fig. 10. Comparison of fatigue crack location in the numerical model and the existing structure

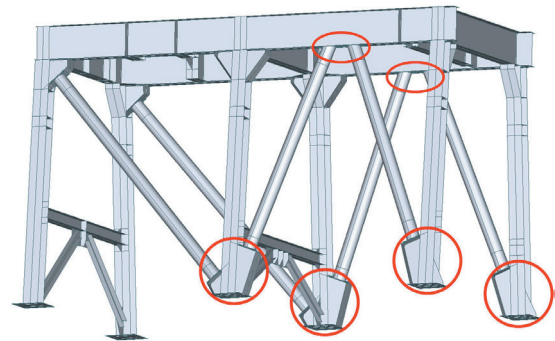
The locations of the cracks present on the crusher's supporting structure and confirmed in the numerical calculations are presented in Fig. 11.

Fig. 11. Fatigue crack locations

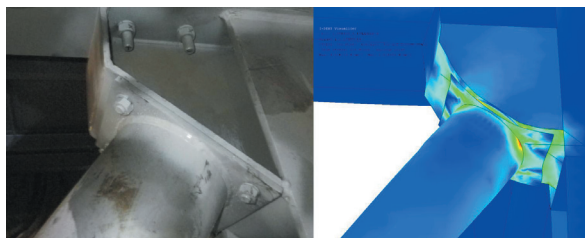
- 1) resonance vibrations in the transverse direction caused by not enough stiffness in the structure in this direction,
- 2) weak design of the joints, which have low resistance to loads due to operating conditions with movement in both horizontal directions (an example of such a design is shown in Fig. 12). The design of the joints would be sufficiently strong in the case of a static load, however the geometry of the gusset plates does not assure proper load transfer in the case of a dynamic load. Lateral forces acting on the faceplate and the bolted connection cause high effort in those elements. Moreover, the joints do not assure smooth stiffness changes. Therefore, strong bending and pulsations are present and cracks occur as a result of rapid fatigue.

Fig. 12. Example of the weak design of the joints

Due to the condition of the existing joints, which exhibit multiple cracks and thus multiple repairs, it was decided to cut out all weak joints and incorporate new redesigned ones. Special care was paid to the joint's design to assure proper fatigue resistance.

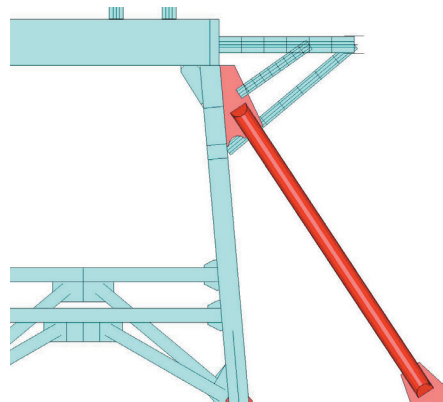
Fig. 13. Side bracing design

The easiest way to increase stiffness would be to incorporate diagonal bracing inside the frame. However, the conveyor line located inside the frame prevents this. Therefore another stiffening solution was designed. Two of three cross-sections of the frame were reinforced with side bracing as shown in Fig. 13. Thus, there are four bracings in total anchored to the concrete foundation and welded to the existing structure. This change was incorporated into the FEM model to confirm its influence on the natural frequencies of the modified supporting structure. The position of the side bracing was mainly determined by the ease of assembly on the already existing structures. The results of the modal analysis of the modified crusher supporting structure are shown in subsection 2.3 of the paper. The results confirm that the position

of the side bracing has a positive influence on the structure dynamics.

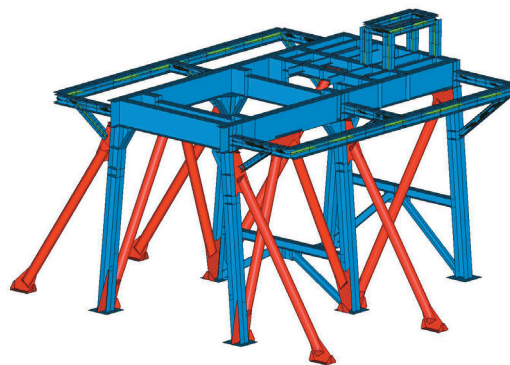
Fig. 14. New design of side and longitudinal bracings

This new solution required the replacement of existing longitudinal bracings with new ones. Fig. 14 shows the new design of the longitudinal bracings incorporated into a geometrical model of the crusher supporting structure. In order to enable easy manufacturing and built process into the existing structure, welding connections were considered on the designing stage.

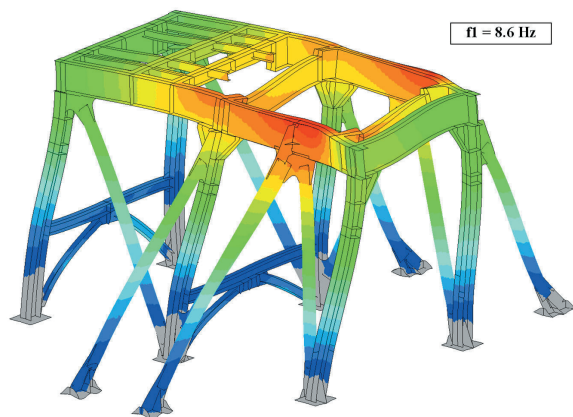
In the first step, a modified model of the crusher supporting structure was checked for resonance issues. Modal analysis of the model confirmed that the natural frequencies of the structure were shifted significantly up. Table 3 lists the frequencies of the first three modes. Fig. 15 presents a deformation plot of the first mode, which was responsible for the resonance vibrations in the existing structure. The first natural frequency is shifted from the excitation frequency and equals: $f_{ex} = 3.33$ Hz, $f_1 = 8.58$ Hz, $f_{ex} < f_1$.

There are no natural frequencies close to the first harmonic of the excitation frequency, which equals: $f_{ex,1h} = 6.66$ Hz.

Fig. 15. Natural frequency mode of the modified crusher supporting structure - Mode 1

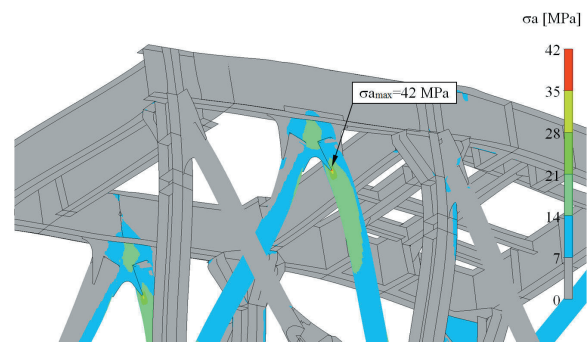
whether the new design of the joints shows proper fatigue resistance. Calculations were carried out using the FEM model in accordance with ISO-5049 standard requirements. As a result of such calculations, the stress amplitude σ_a at each point of the structure was obtained. The maximum value calculated in the structure was found in the gusset plate of the longitudinal bracing: $\sigma_{amax} = 42$ MPa.

Fig. 16 shows a view on this area with the stress amplitude plot. The maximum stress peak is located in the welded connection of the gusset plate and pipe section. In this area, a K3 notch was designed where the permissible stress amplitude equals: $\sigma_{aperm} = 60$ MPa.

Fig. 16. Stress amplitude σ_a in the modified crusher supporting structure

A comparison of both values confirms that the modified structure of the crusher supporting structure is safe from the fatigue resistance point of view.

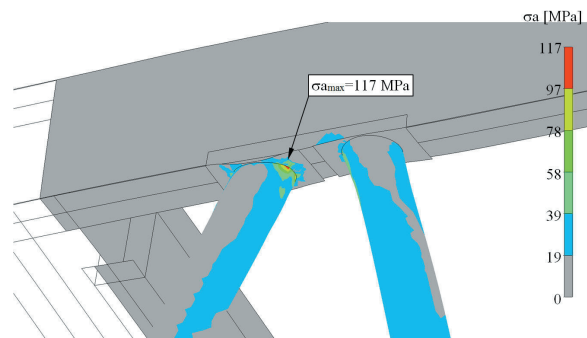
As a comparison of the existing and new design, Fig. 17 presents the same area of the gusset plate in the old design. The maximum stress amplitude in this area equals $\sigma_{amax} = 117$ MPa.

This value exceeds the permissible values of the stress amplitude, which was indicated by the fatigue cracks in the maximum stress area.

Fig. 17. Stress amplitude σ_a in the existing crusher supporting structure [MPa]

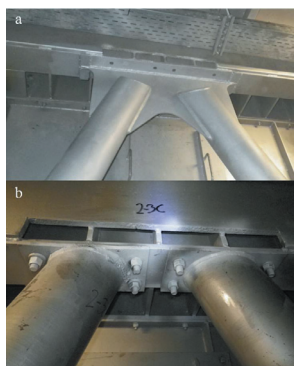
Fig. 18. Weak joint; a) after, and b) before modification

In the previous section, the new designs of the modifications to the crusher supporting structure were presented. The results of the dynamic (modal) and fatigue calculations confirmed that the modified structure should be safe under normal operating conditions. The new design of the side and longitudinal bracings were incorporated into the structure prior to removal of existing weak joints and bracings. Fig. 18 shows an example of the redesigned joint before and after modification.

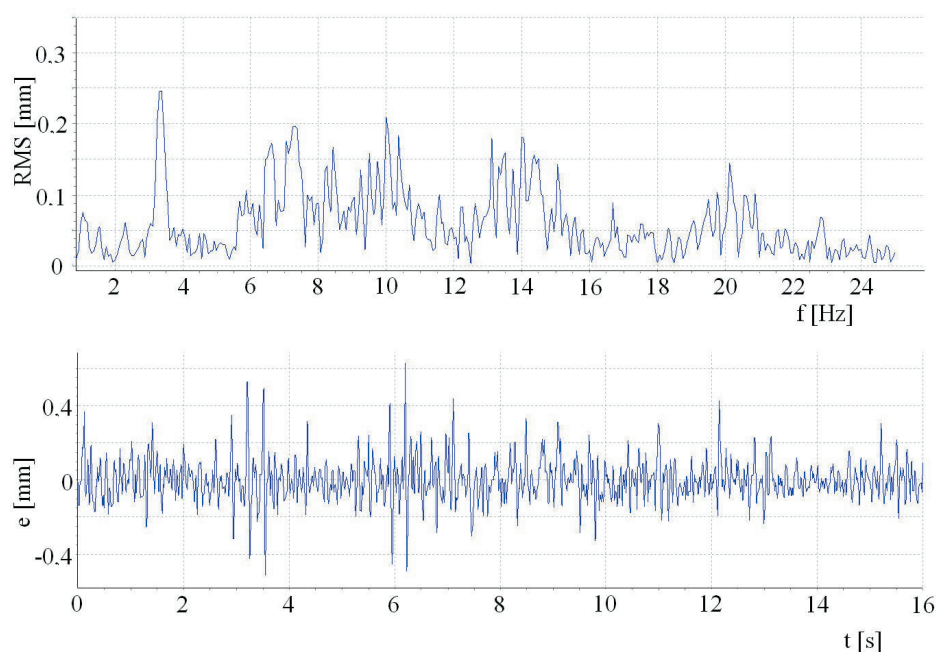
modified structure in order to confirm that resonance was no longer present during operation. The tests were performed with the use of a COMMTEST vb7 vibrometer at the same locations as the tests on the original structure. The vibration spectrum and time traces obtained are shown in Fig. 19. There are no resonance vibrations present in the time trace of the measured signals. The RMS value of the vibrations is 400% lower compared to the vibrations of the original structure.

Fig. 19. Time and spectrum displacement signal of transverse vibrations of the modified structure

In the final stage, the modified structure was tested using a vibration measuring device. The test measurements confirmed that there was no resonance and that the structure exhibited proper behaviour during normal operation.
