Detecting Groan Sources in Drum Brakes of Commercial Vehicles by TVA-FMEA: A Case Study

Original Scientific Paper

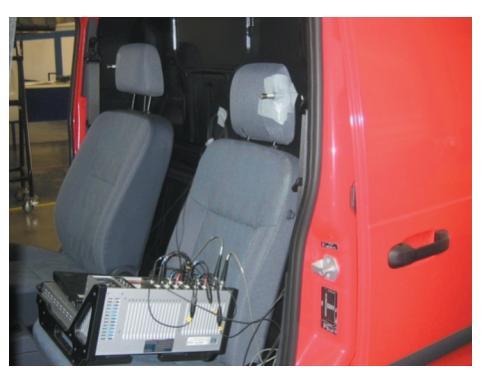
Fig. 10. Microphone positioning in cabin onto driver head guard

The sound pressure level in-cab has been measured by mounting microphones in the ears of drivers and passengers. The location of the microphones was as shown in Fig. 10. Microphones were placed as close as possible to the ears of the passenger and driver. The type of microphones used in the measurements is the Brüel & Kjaer 4189–A–021.

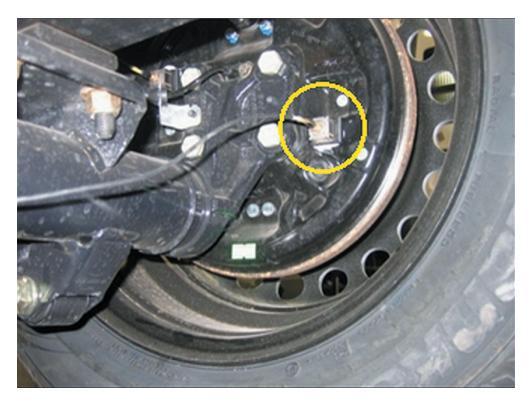
Fig. 11. Accelerometers mounted on the backing plate

collecting data with accelerometers and microphones located at the outside of the backing plate, (2) taking measurements from both the leading and trailing brake shoes and (3) measurement of the leading shoe of a faulty drum brake unit. To begin with, double accelerometers were placed onto the backing plates of the left and right rear drum brakes as shown in Fig. 11. The accelerometers used were 4 mA - 100 mV/g and type 7254A-100 and 2258-100. In addition, optical readers were used to compare the collected data with the vehicle speed. Data collected for the cabin sound level and data for the backing plate acceleration were transferred to an FFT analyser for processing. Data were analysed using Head Acoustics Artemis and SQ Lab-III via computer software. The vehicle used was a van type vehicle with 90 HP and steering on the right affected by brake groan. In the test, only selected vehicles with similar properties were compared. Therefore, trouble-free vehicles to be tested had the same properties as the troubled vehicle.

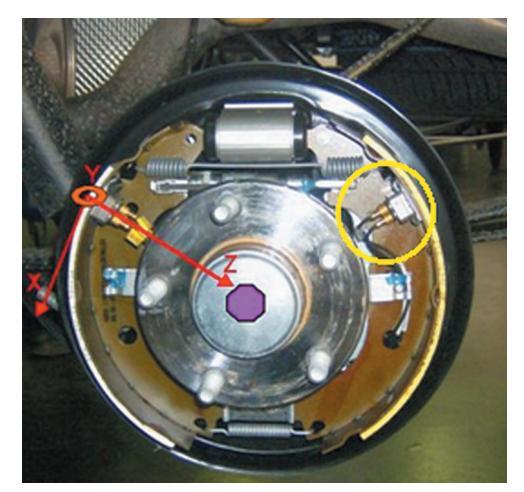
Fig. 12. Accelerometers mounted on the leading and rear brake shoes

The second stage of the NVH measurement in the brake mechanism was to measure acceleration of the brake shoes. For this, accelerometers were mounted in the leading and trailing shoes as shown in Fig. 12. The color of the leading shoes is white and the trailing shoe yellow. However, records collected from the separated shoes did not yield important results. Therefore, a third trial was considered and the required set-up of the equipment was carried out. Accelerometers were mounted on the top and bottom portions of the leading (white color lining) brake shoe as shown in the Fig. 13. Then, test drives for generating brake groan noise were performed. Data collected from the last measurements show very interesting results.

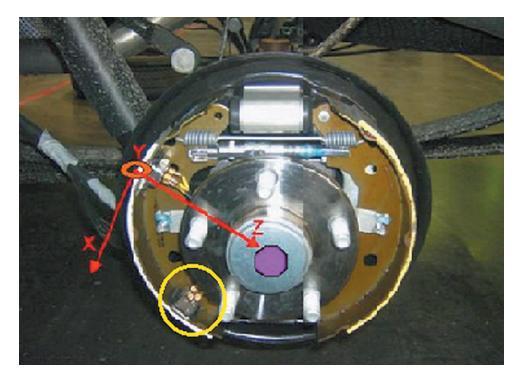
Fig. 13. Positioning the accelerometers in the top and bottom portions of the leading shoes

Analysis of the data coming from the first and second measurements did not yield any clear conclusions. However, the third measurement study did help to explain the collected data very clearly and pointed the way to identifying root cause of the problem. In the third trial, brake groan was found to be due to an activated faulty brake, which is triggered by the front metal shoe (leading) on the both sides of the drum brake of the vehicle as shown in Fig. 13. This is why this experiment was performed with the help of two accelerometers mounted in front metal shoe (the shoe in driving direction) of the drum-brake vehicle. The recordings are presented in Fig. 14. In Fig. 14, the first row indicates the measurements of the accelerometers located in the rear drum brake shoes that are, RL-LT (rear left-leading top) measures groan noise frequencies in x, y, z directions and similarly RL-LB (rear left- leading bottom) in x, y, z directions. For the right tyre, the accelerometer measured frequencies at RR-LT in the x, y, z directions and RR-LB in the x, y and z directions. After having completed an analysis of the graphics, it can be seen that the left side of the vehicle does not have any serious problems. But on the right side, variability in the acceleration of vibration can be clearly observed between 200 to 300 Hz. When we look at the charts for the right wheel of the vehicle, the x-axis of both top and bottom points shows the same variability. Moreover, on the y axis, the top portion includes more interaction, which hints that the source of the excessive vibration is near the brake lining. Finally all measurements performed in the tests point to something being wrong with the brake lining. In contrast to the other axes, records taken from the z axis show no big change. In the third test, the vehicle brake groan disappears spontaneously after applying the brake for a certain period of time (groan noise is completely eliminated after driving 5 km in traffic).

During the third trial, the frequency of the knocking groan noise occurrence at the drum brake was also measured and a continuous error mode has been detected. Although vehicle speeds and brake forces differ from each other, records show that the braking groan noise, which is heard as "knock" at each rotation of the wheel, repeats itself regularly. The knock occurs when the wheel speed was calculated to be 2.7 cycles per second, more specifically the knocking occurrence frequency is ~2.75 rotation per second. Thus, measurements show knocking at each rotation in the braking system as shown in Fig. 15. The groan noise recorded in the cabin is shown in Fig. 16. In Fig. 16, the blue line (R. Right - L. Bottom X) indicates groan noise magnitude collected from the lower portion of the brake metal shoe and the red line"(R. Right - L. Top X) shows the data from the top portion of the same metal shoe. The green line (R. Right - Microphone) seen in Fig. 16 indicates the levels of braking groan noise measured in the cabin. Although the groan created during braking is actually very high pitched, we hear only a small portion of it due to the quite effective insulation applied to the cabin. A third trial, in addition to the studies described
